Nornda Automotive

Assembly Instructions

To Suit: Buick

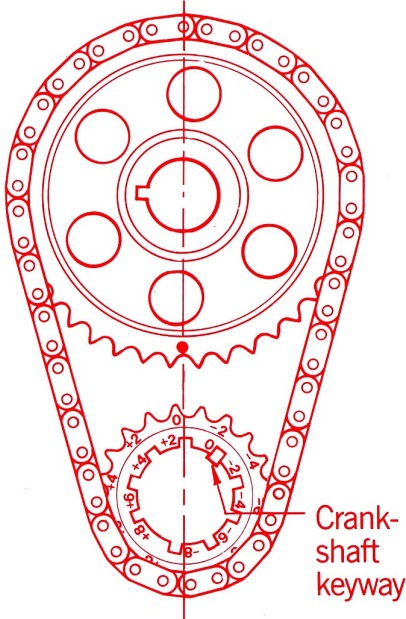
1 Standard Timing

Using keyway and tooth marked '0'

Warning: Do not use the keyway marks to time engine. Always align the crank gear tooth timing mark to cam gear timing mark.

Note: Check for clearance between timing chain and oil gallery boss. On some later blocks it may be necessary to remove material from the top side of the boss for chain clearance.

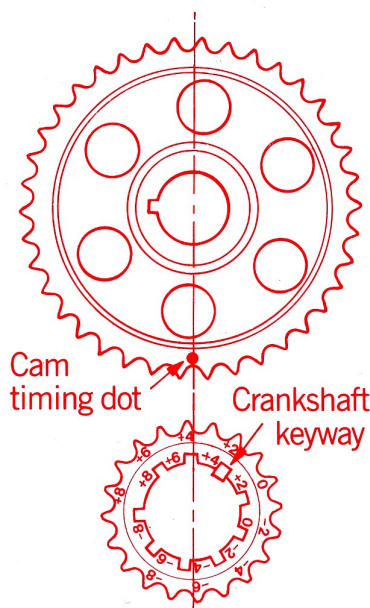
2 Advanced Timing

1. Before assembly carefully inspect crankshaft sprocket. Note the position of each keyway on the inside diameter and the position of the equivalent timing mark on the outside gear tooth.

2. Fit the crankshaft sprocket to the crankshaft, ensuring that the keyway selected is aligned to the crankshaft keyway.

3. Rotate the crankshaft anti-clockwise until the same advance position on the outer sprocket is aligned with the timing mark on the camshaft sprocket.

Advanced 4° as drawn

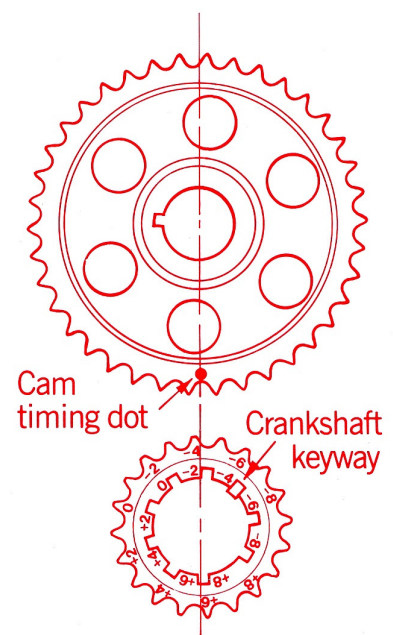
3 Retard Timing

1. Before assembly carefully inspect crankshaft sprocket. Note the position of each keyway on the inside diameter and the position of the equivalent timing mark on the outside gear tooth.

2. Fit the crankshaft sprocket to the crankshaft, ensuring that the keyway selected is aligned to the crankshaft keyway.

3. Rotate the crankshaft clockwise until the same advance position on the outer sprocket is aligned with the timing mark on the camshaft sprocket.

Retard 4° as drawn
